Breakaway of *Grand Pioneer* and *AAL Fremantle*

Port of Fremantle, Western Australia | 17 August 2014

ATSB Transport Safety Report
Marine Occurrence Investigation
313-MO-2014-009
Preliminary – 21 October 2014

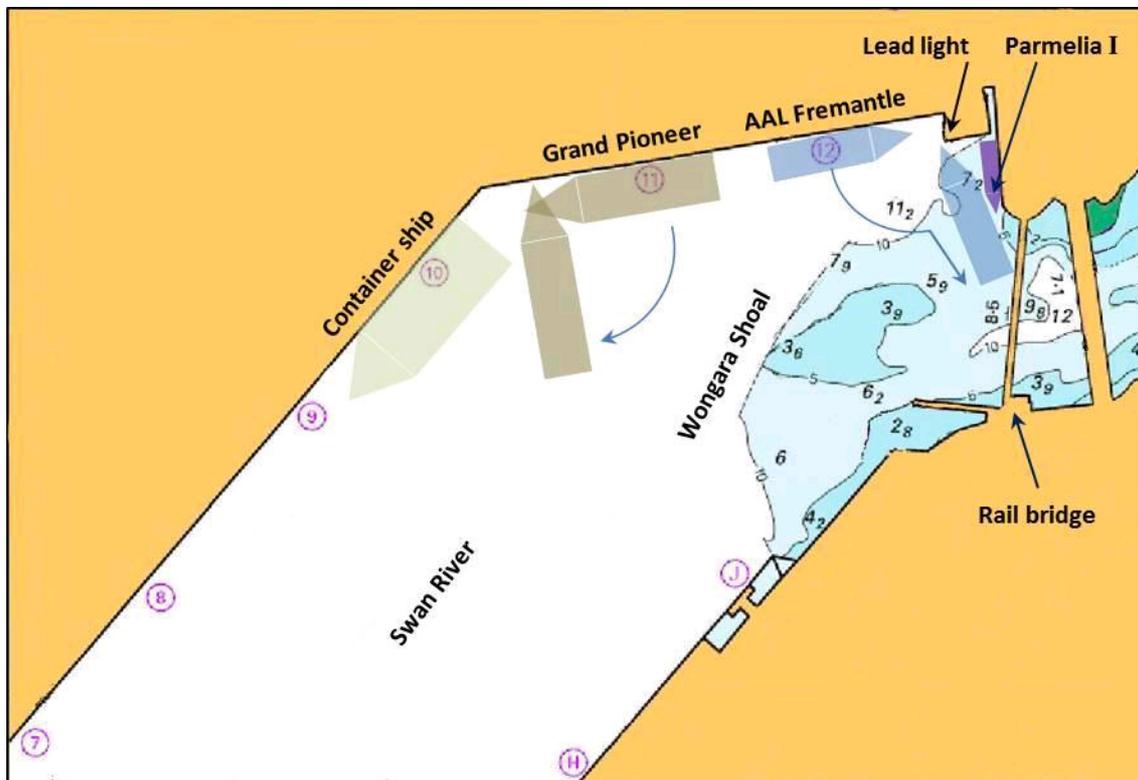
Figure 1: Section of chart Aus 113 indicating berthed ships and their later movement

By 2210, *Grand Pioneer* had swung until its port shoulder was about 15 m from the container ship at berth 10 (Figure 1). *Grand Pioneer's* head lines and forward spring lines had held and its port anchor was let go. The bow thruster and main engine were used to maintain the ship's position.

At 0115, two tugs had been made fast to *AAL Fremantle*. As there was insufficient water over Wongara Shoal (Figure 1) for the aft tug to manoeuvre close to the ship, its line was attached to a ship's mooring line.

By 0300, *AAL Fremantle* was all fast at berth H (Figure 1).

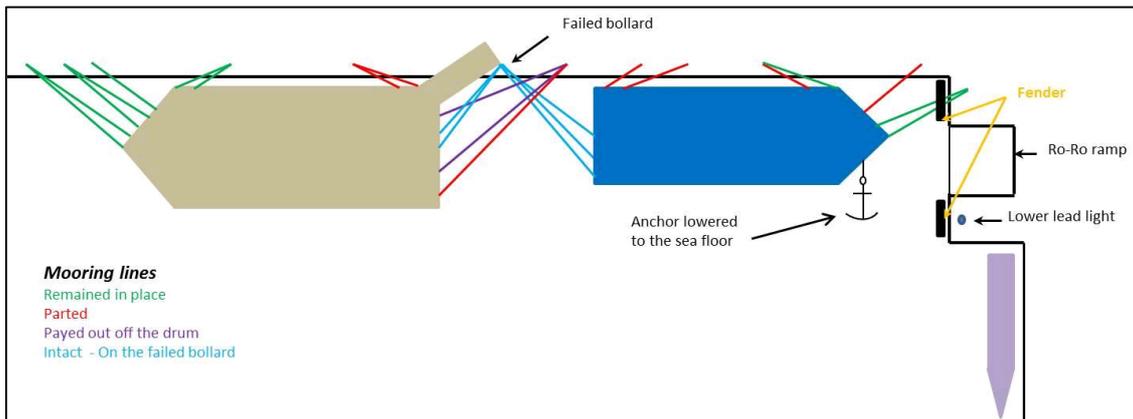
Figure 2: Indicative diagram showing mooring arrangements (not to scale)

In his cabin, *AAL Fremantle*'s master heard the sudden rise in wind speed. From the aft facing cabin window, he saw the *Grand Pioneer*'s stern moving away from the wharf and the three stern lines could no longer be seen (Figure 2). Concerned, the master immediately went to the bridge and started preparations to manoeuvre the ship.

During the sudden weather event, the bollard that had held all three of *AAL Fremantle*'s and two of *Grand Pioneer*'s stern lines broke away from the wharf and fell into the water. Other mooring lines on both ships had also parted or payed out, resulting in both ships breaking away from the wharf.

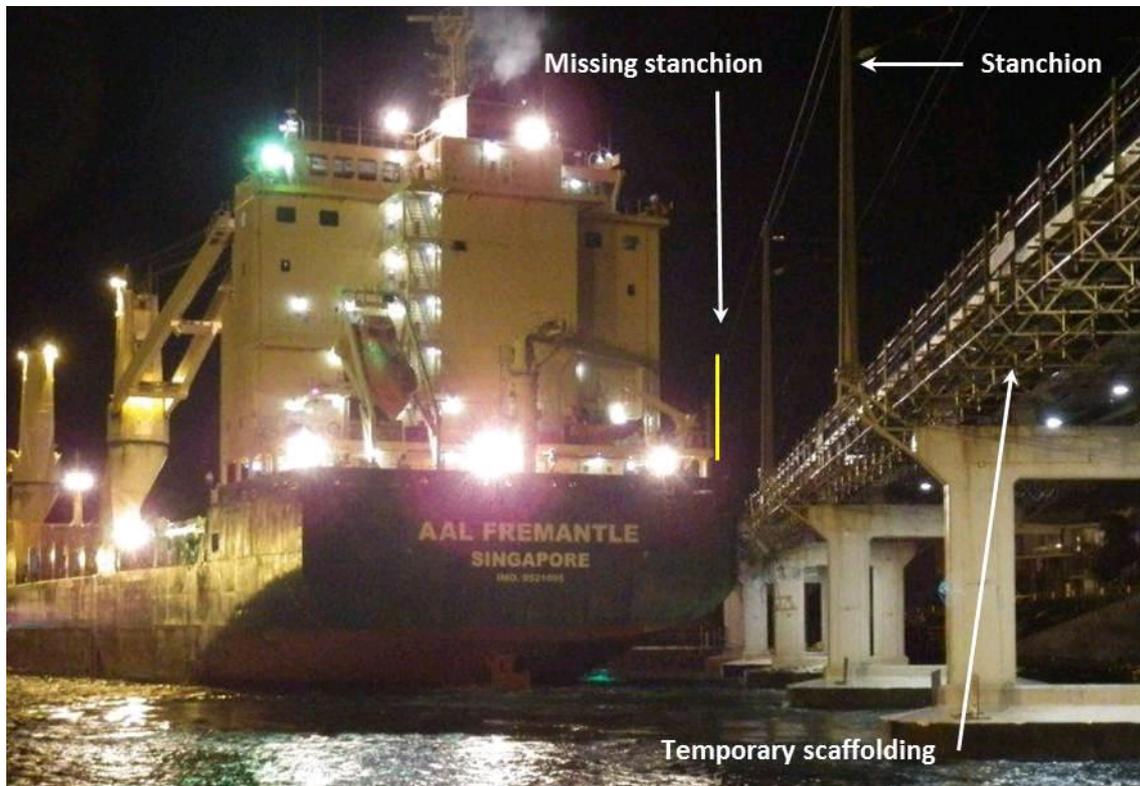
Figure 3: *AAL Fremantle* near the Fremantle rail bridge during the incident

At 2208½, *AAL Fremantle's* starboard quarter struck a stanchion⁵ on the Fremantle rail bridge and brought it down. Temporary scaffolding on the side and under the bridge was damaged, and the track's alignment was disturbed (Figure 3). Moments later, *AAL Fremantle's* hull, about midships, contacted the starboard shoulder of the bunker barge, *Parmelia I* (Figure 1), and then stopped moving astern. *AAL Fremantle's* two remaining head lines were slack but the remaining forward spring line was still under tension.
