Grounding of *Maersk Garonne*

Fremantle, Western Australia, 28 February 2015

ATSB Transport Safety Report
Marine Occurrence Investigation
319-MO-2015-002
Preliminary – 21 May 2015

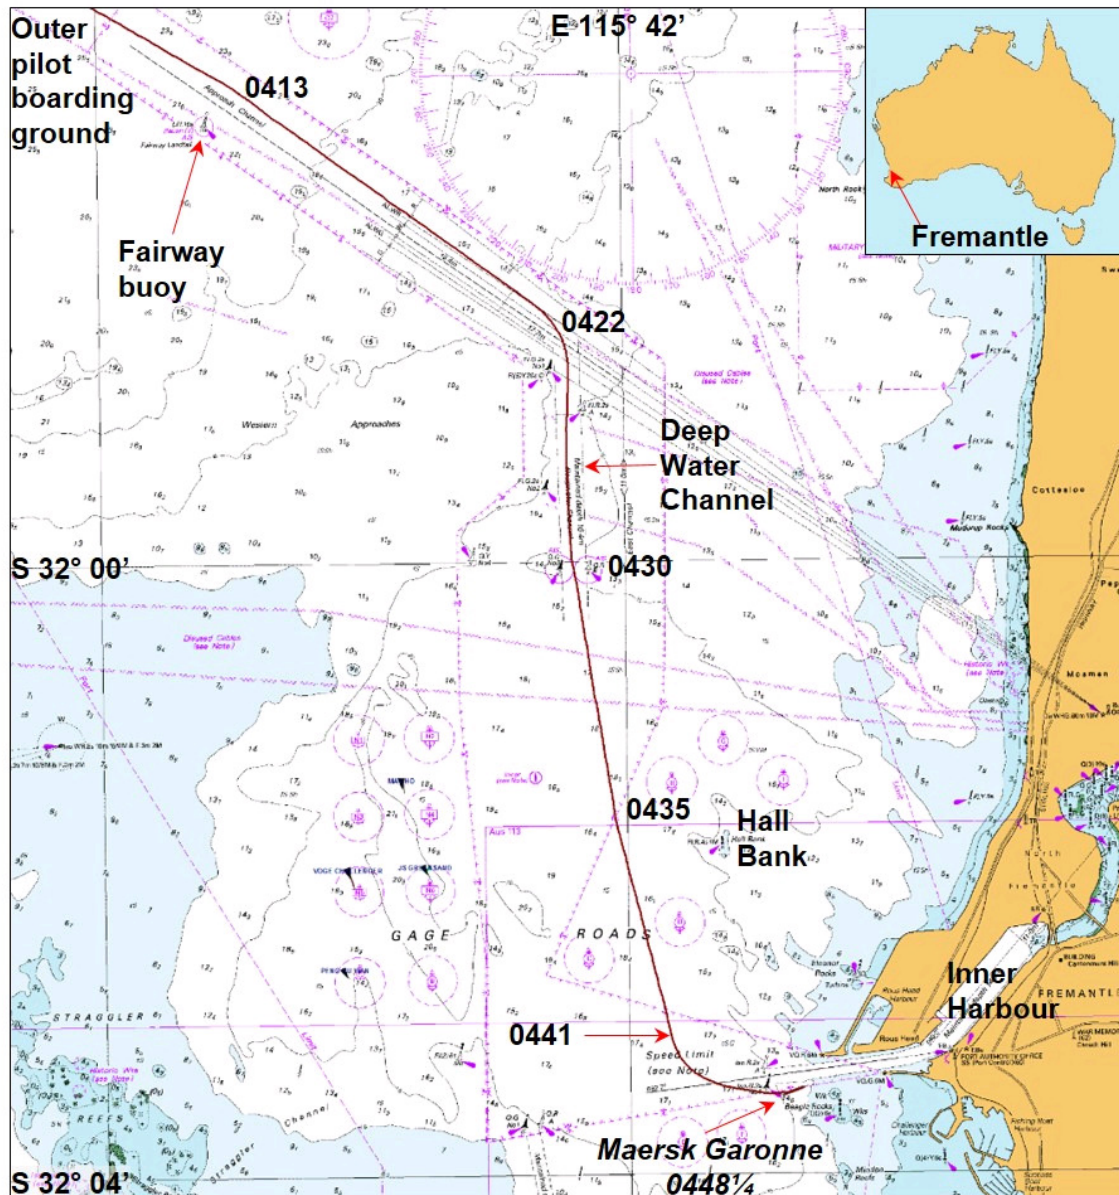
Figure 2: Section of navigational chart Aus 112 showing the track of *Maersk Garonne*

At 0413, the ship passed the fairway buoy (Figure 2) and continued in a south-easterly direction at 14 knots, toward the Deepwater Channel, less than 3 miles⁷ distant. At 0422, the pilot ordered 10° of starboard helm and, at 0426, a course of 178°.

Meanwhile, at 0435, the pilot contacted the VTS and reported that the ship was passing Hall Bank (Figure 2) and confirmed its berthing arrangements. The VTSO replied that *Maersk Garonne* was all clear to the Inner Harbour and that the tugs were getting underway. The course was then altered to 165° and 2 minutes later, the main engine was reduced to half ahead.

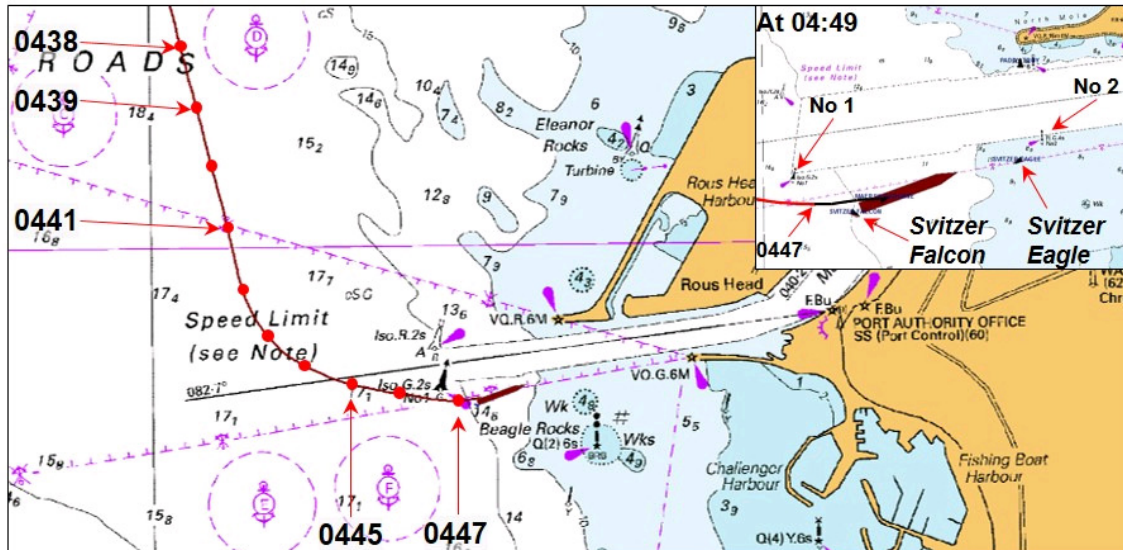
Figure 3: Section of chart Aus 113 showing *Maersk Garonne's* track

At 0441 the pilot ordered 20° of port helm and slow ahead on the main engine to commence the turn to the entrance channel (Figure 3). Thirty seconds later, the pilot ordered hard port to reduce the ship's speed and not arrive at the entrance beacons before the two tugs were in position.

Maersk Garonne's speed was 7.6 knots and over the following 70 seconds the ship slowed and came to a gentle stop as its hull rode up onto the sand and mud bottom to the south of the entrance channel. At 0448¼, the chief mate stated that the ship had no speed and shortly thereafter the pilot ordered the main engine to stop. *Maersk Garonne* was aground in position 32°03.47' S, 115°43.21' E (Figure 3 Inset).
